The San Francisco Earthquake and Fire 1906

The
San Francisco Earthquake and Fire

A BRIEF HISTORY OF THE DISASTER

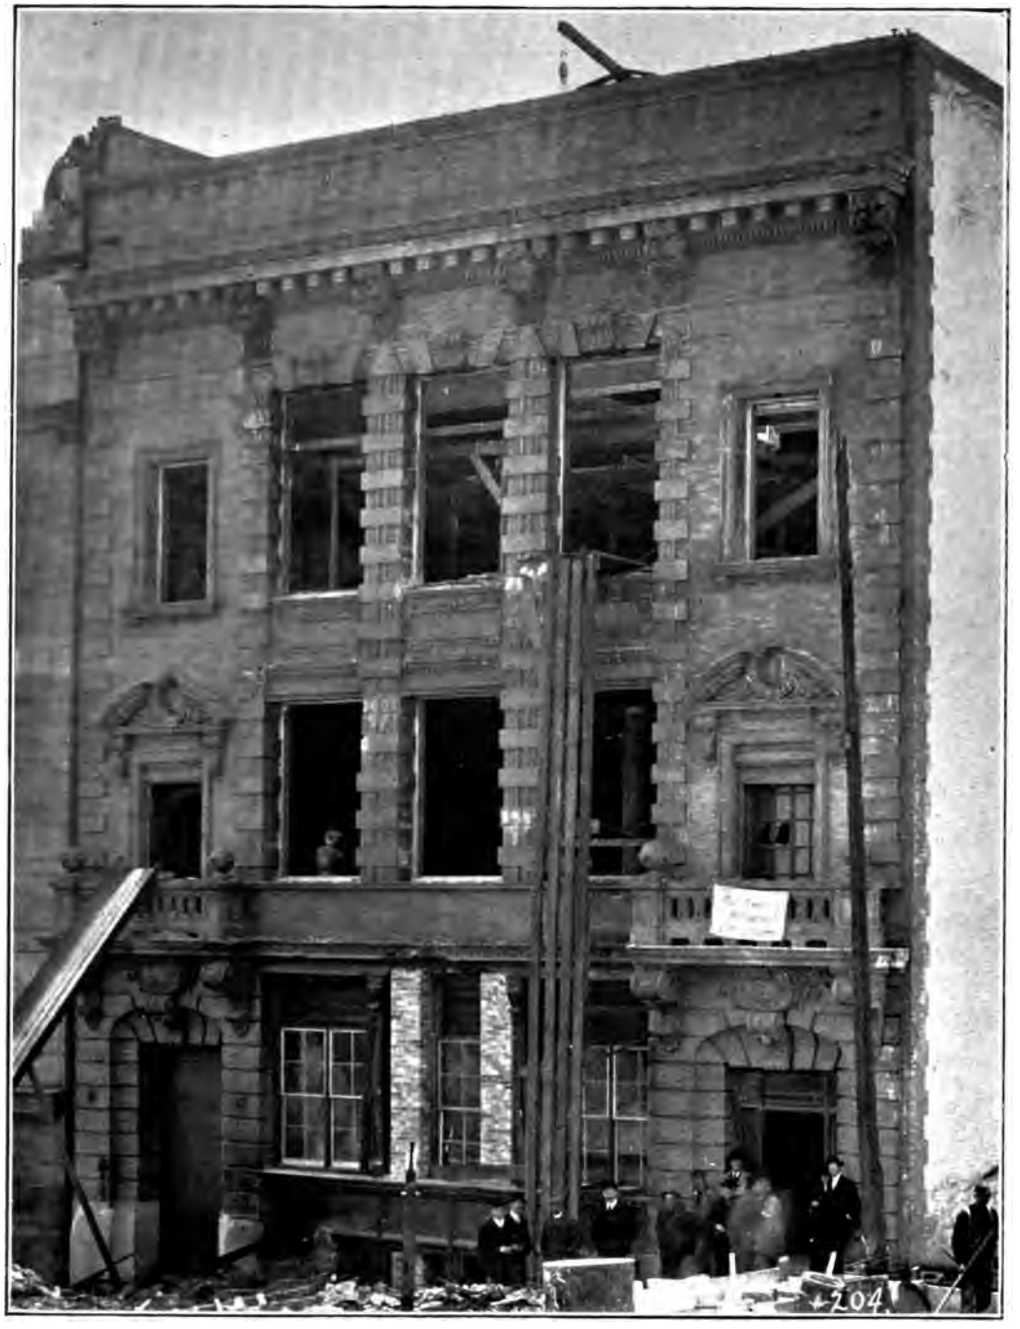
PACIFIC STATES TEL. & TEL. CO.'S East Office, 821 Hyde St. The façade consists of a granite base, with buff terra-cotta brick and terra-cotta ornamentation above. The granite base is slightly damaged, but the rest of the front is in good condition. Two cast-iron pillars, at the first-story level, were deflected by the fire, and have been reinforced by new brick piers. This building was subjected to a normal fire only. It is structurally uninjured. The expanded metal concrete floors are only in fair condition, the cinder concrete having been of poor quality originally. The concrete column protection and the floor finish of cement remain in good condition.

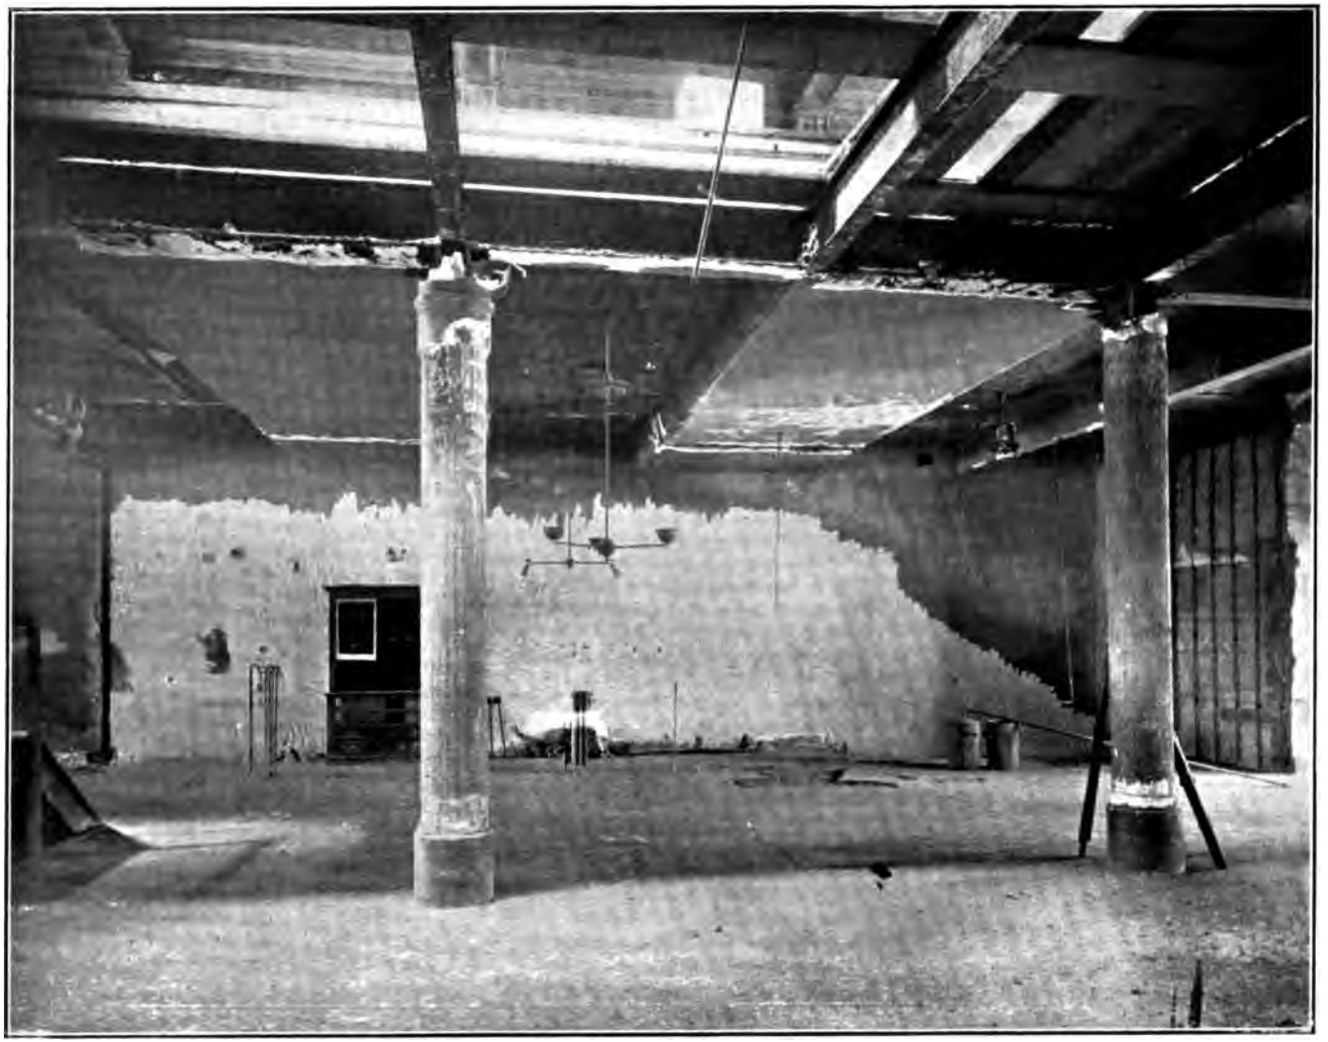
PACIFIC STATES TEL. & TEL. CO.'S East Office. Showing the typical condition of the concrete column protection and the damage to the cast plaster ornamental caps. The concrete protection should not have been omitted where the caps were placed. The photograph was taken after repairs had been begun.

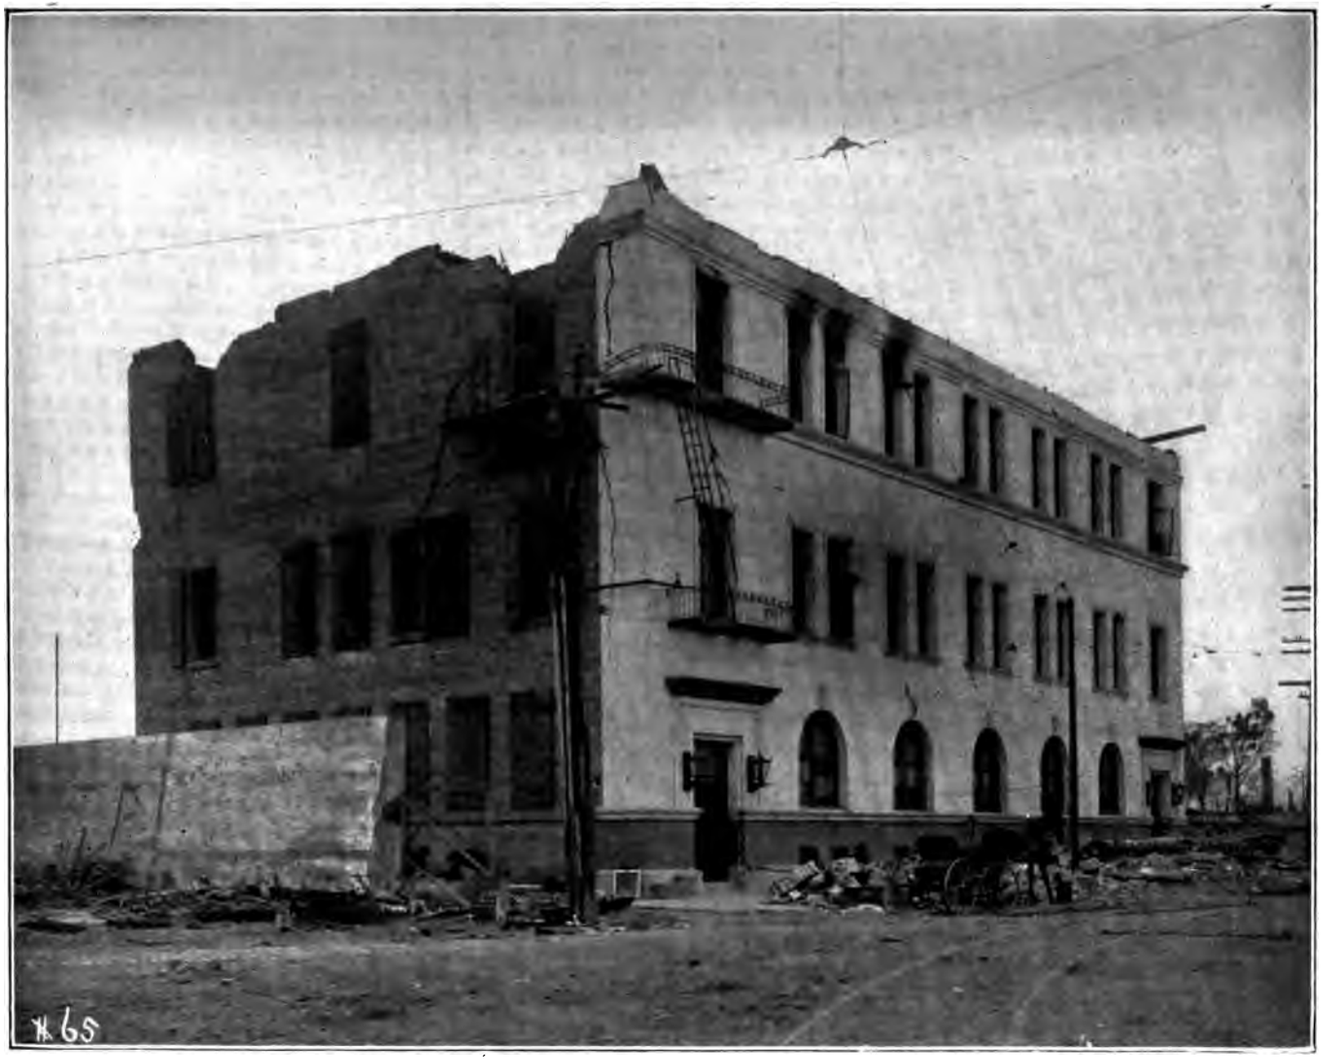
PACIFIC STATES TEL. & TEL. CO.'S South Office, 74 and 76 West Mission Street. The façades consist of gray artificial stone to the water table, buff terra cotta brick to half the height of the first story and white cement finish on common brick above. This building had a temporary wood roof supported by the fourth floor, it being intended to increase the height of the building later. The top of the side walls and the parapet walls were overthrown, and portions of the walls were cracked and badly damaged by the earthquake. The two lower stories were provided with metal-covered window frames and sash, with wire glazing, which successfully preserved the contents of these stories. Fire was communicated to the top story through the window openings, which were finished with ordinary wood frames and sash. There was a large amount of expensive equipment and combustible contents in this story, which produced an intensely hot fire. The steel framing and the Roebling concrete floors and column protection remain in first-class condition.

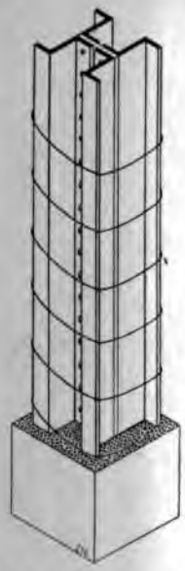
Efficient Concrete Column Protection.

The difference in the efficiency of the two methods of column covering is particularly noticeable in this building. In the three lower stories, where the protection was of concrete, it is entirely uninjured, while in the upper stories, where the protection consisted of 3″ hollow tile blocks, and where the fire was less intense, it was badly damaged and has fallen away in numerous places.

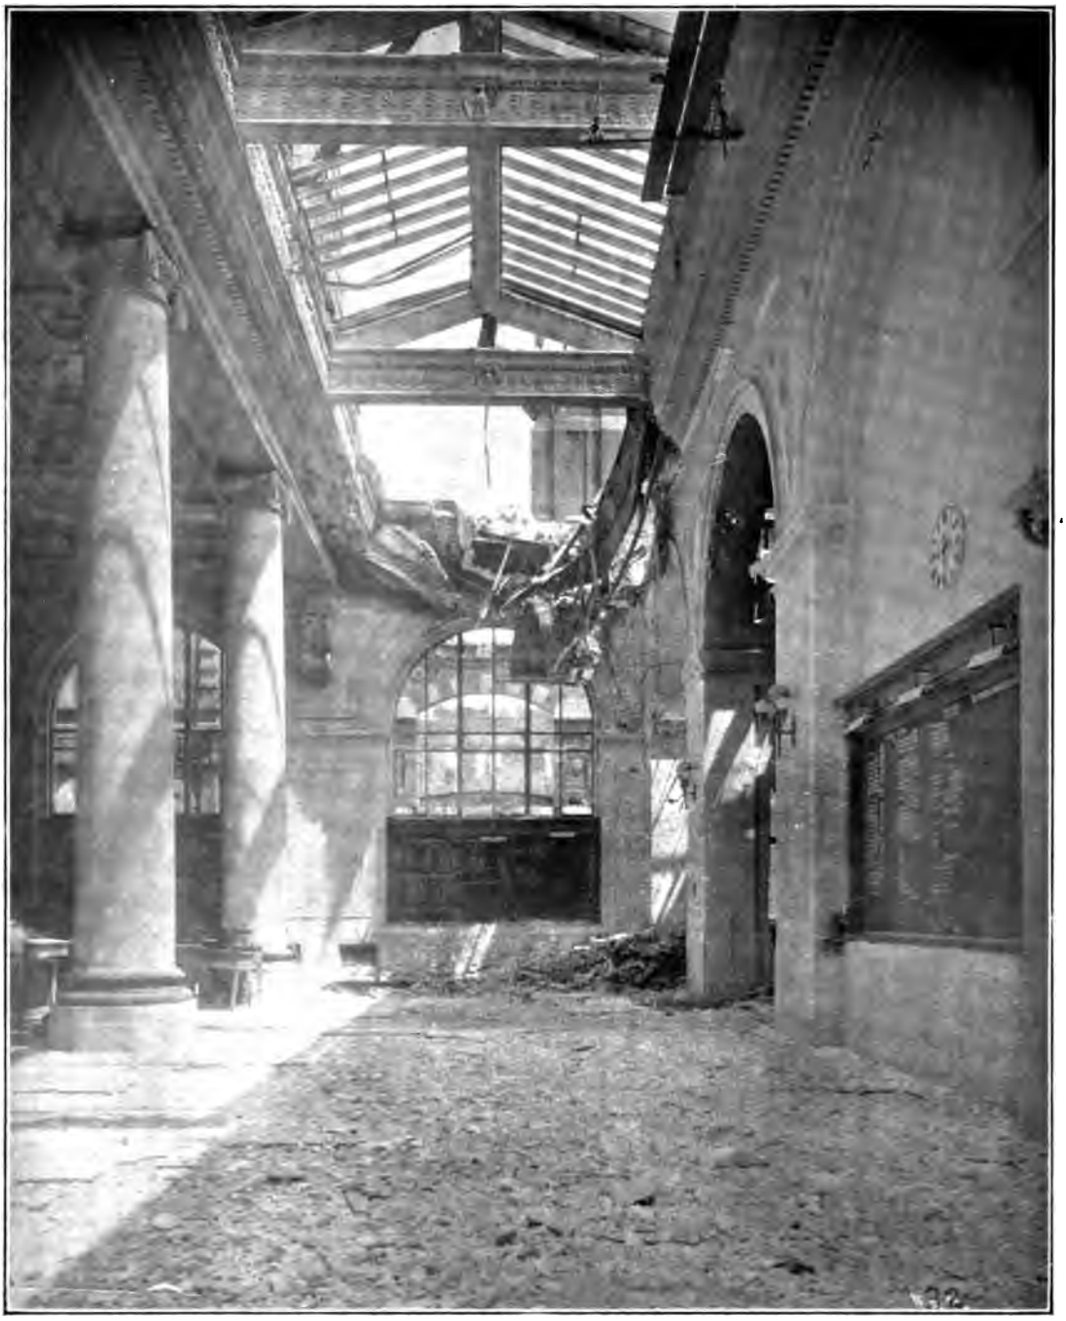
MERCHANTS' EXCHANGE BUILDING. Showing the damage to the exchange room by the earthquake. A section of a six-story building on the opposite side of Liedesdorff Street fell across the street on the roof and skylight of this corner of the room, carrying with it two vaults. One of these fell into the exchange room, and can be seen on the floor at the left hand side. The other is lodged on the roof near the corner of the building amongst other *débris*. Excepting this injury, the exchange room has sustained but little damage.

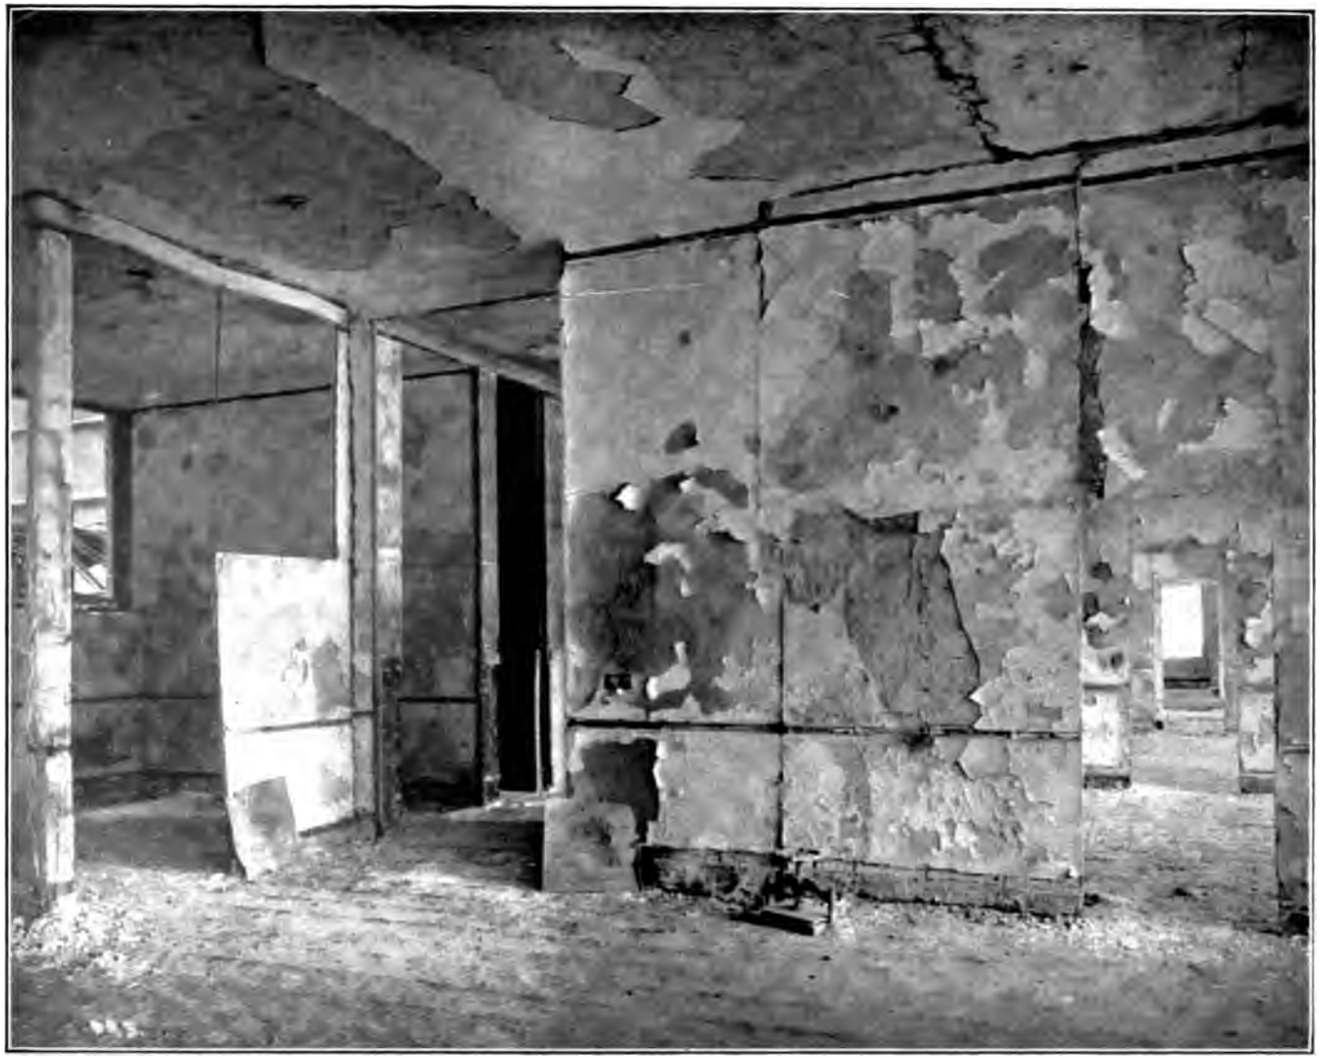
MERCHANTS' EXCHANGE BUILDING. Third Story. Showing typical condition of the Roebling concrete floors and wire lath and plaster ceilings and partitions. This view was taken immediately after the fire. A small amount of plaster on the floors represents practically all the *débris*.

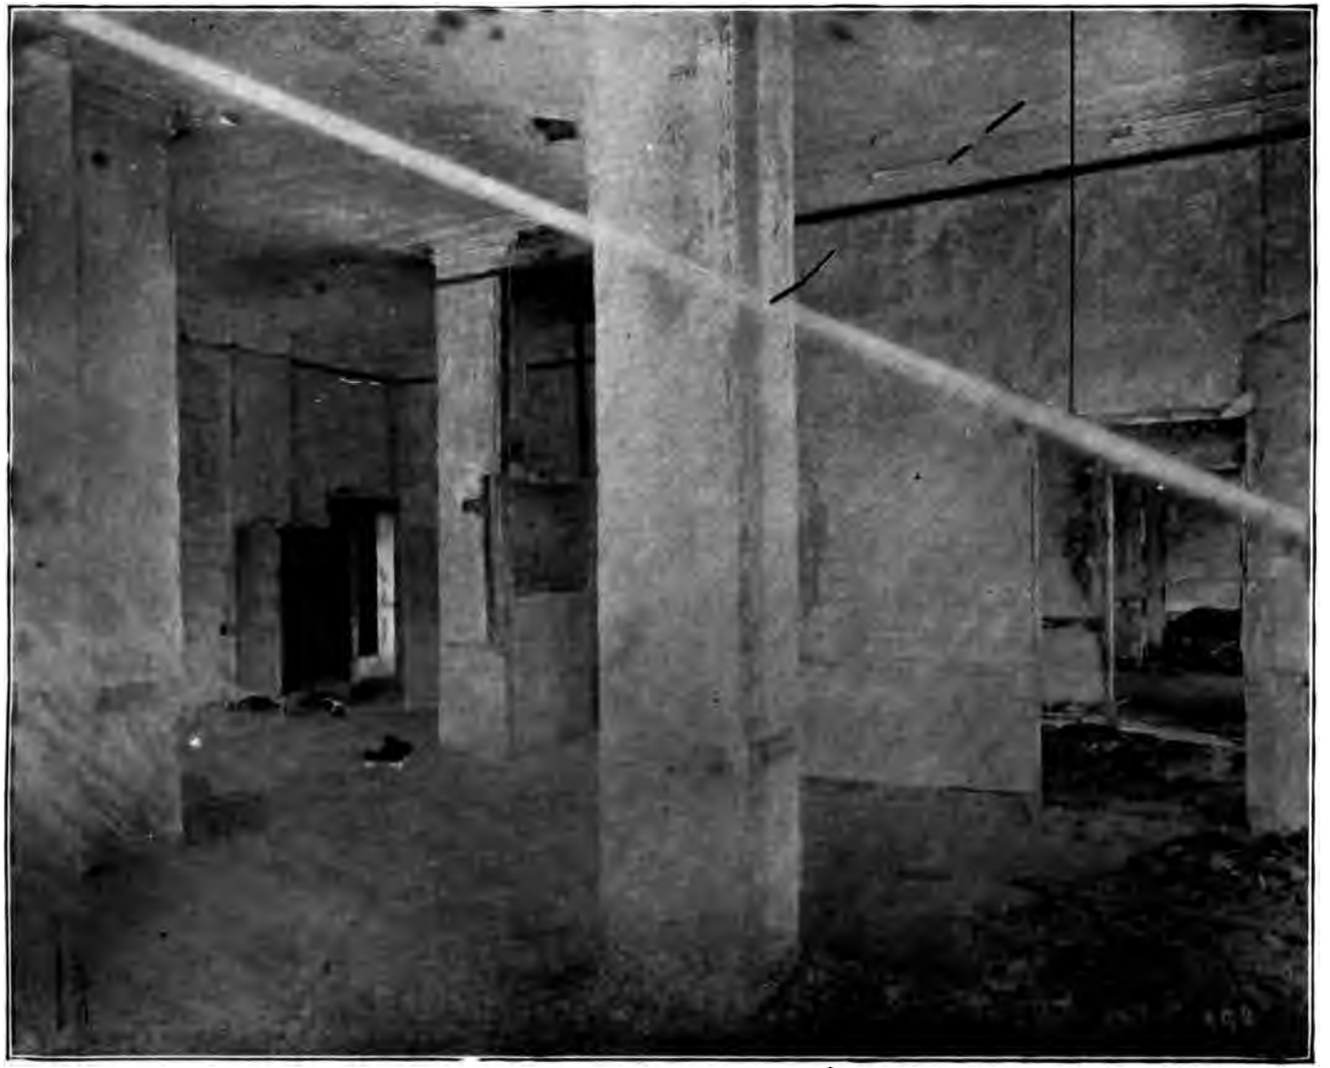
KOHL BUILDING. Typical view of the condition of the partitions in the portion of the building damaged by fire. The column protection was of double metal lath and plaster. The partitions were of the 2″ solid metal lath and plaster type, and the doors and all the trim were of metal-covered wood.

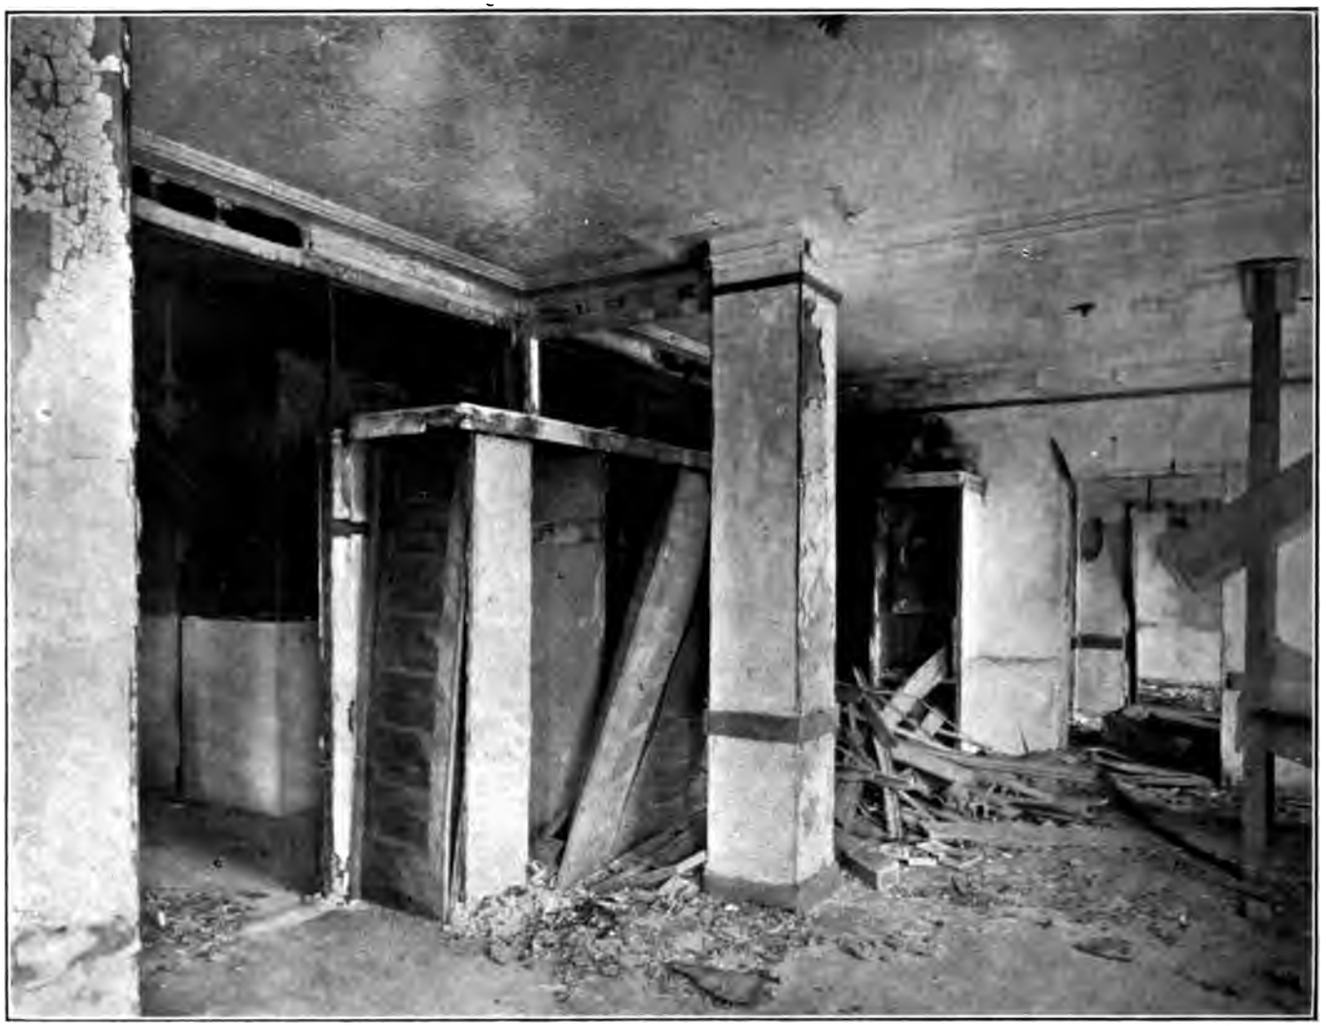
KOHL BUILDING. Typical view of the small damage to this building by fire. The concrete floors are finished in cement and are but little damaged in the parts subjected to fire.

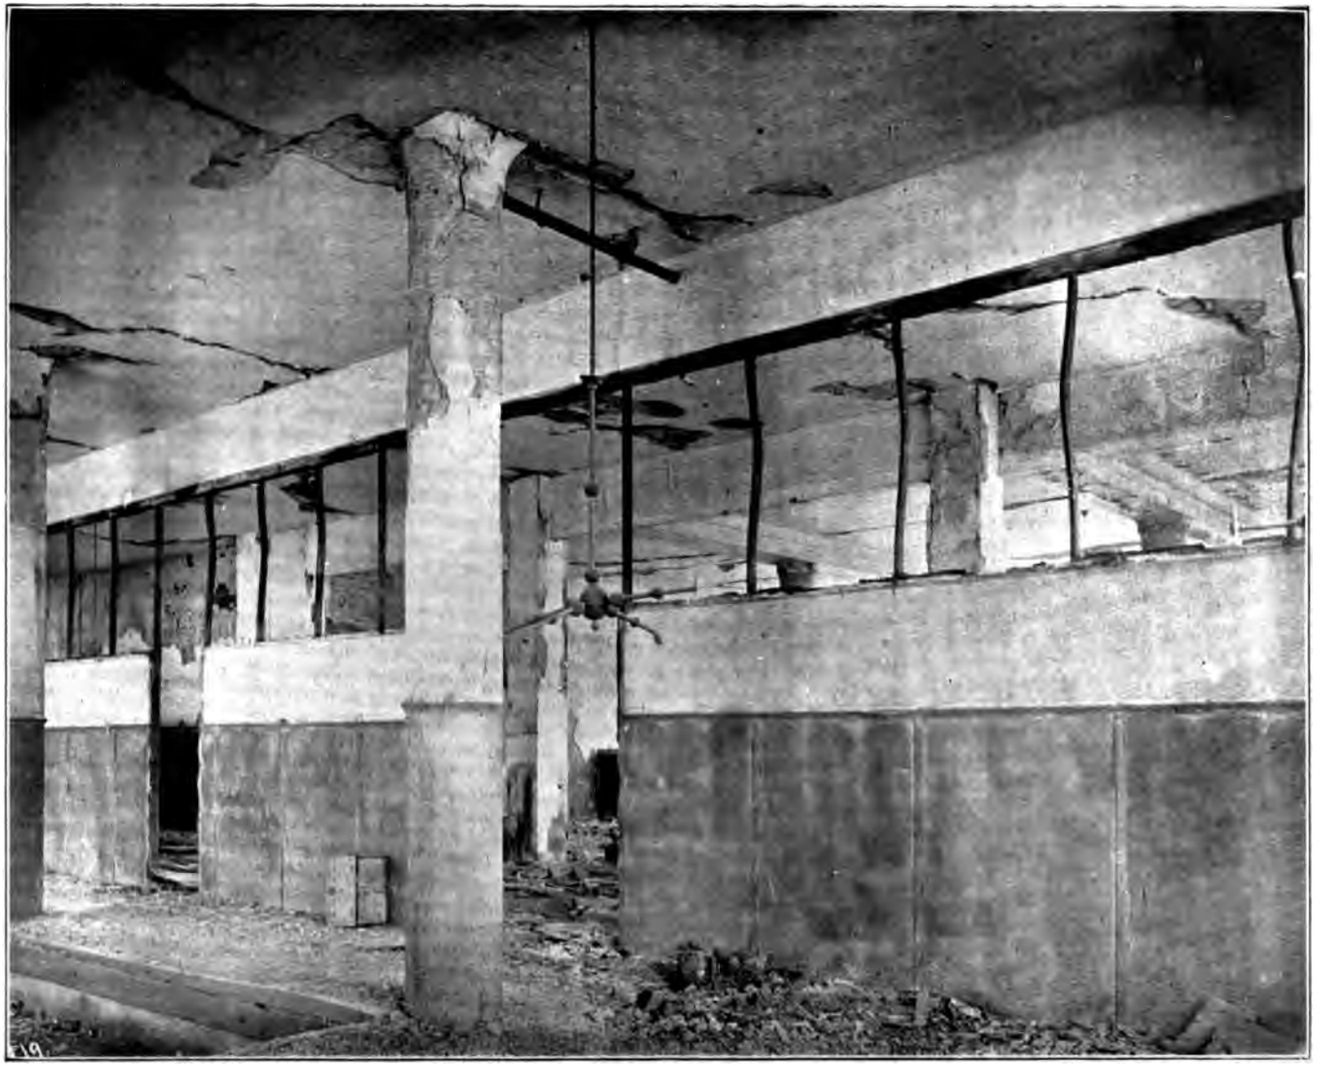
WELLS-FARGO BUILDING. First Story. Showing 4″ hollow metal lath and plaster partitions (with large sash light openings) remaining in position, and the earthquake cracks in the lath and plaster ceiling. The metal lath and plaster column protection is but slightly damaged.

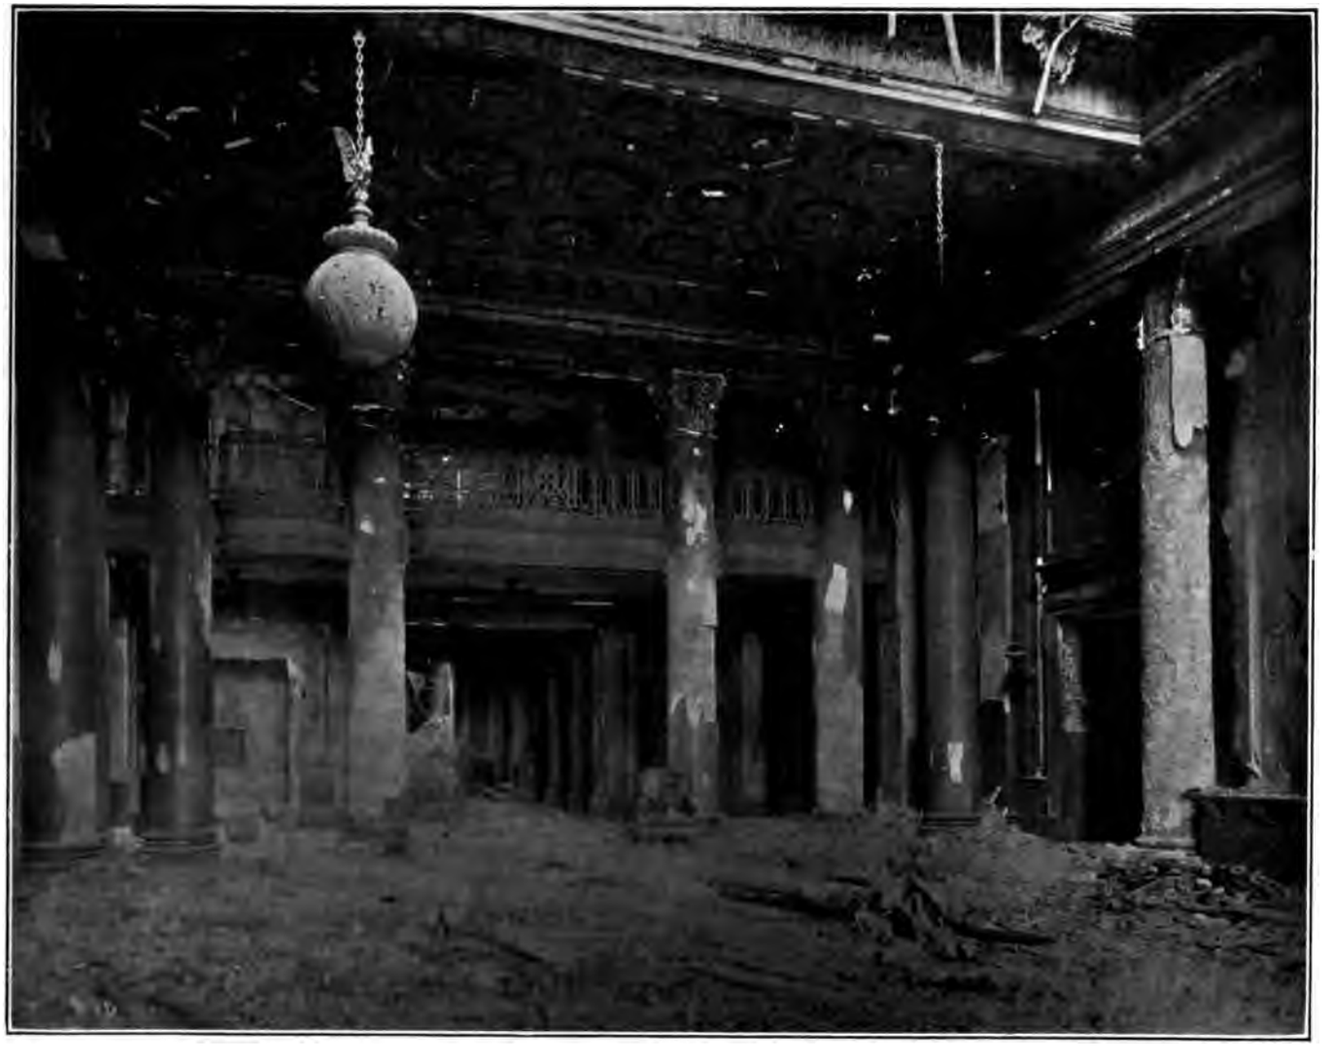
HOTEL ST. FRANCIS. Interior of the main lobby, looking from the entrance. The ornamental effects were produced by the Roebling method of light steel furring and wire lathing. The plaster caps were cast and are badly damaged. The columns are protected with cinder concrete, a defect in the design showing on the right-hand side where the protection was omitted behind the cap near the top. This portion of the building was subjected to a very moderate fire.

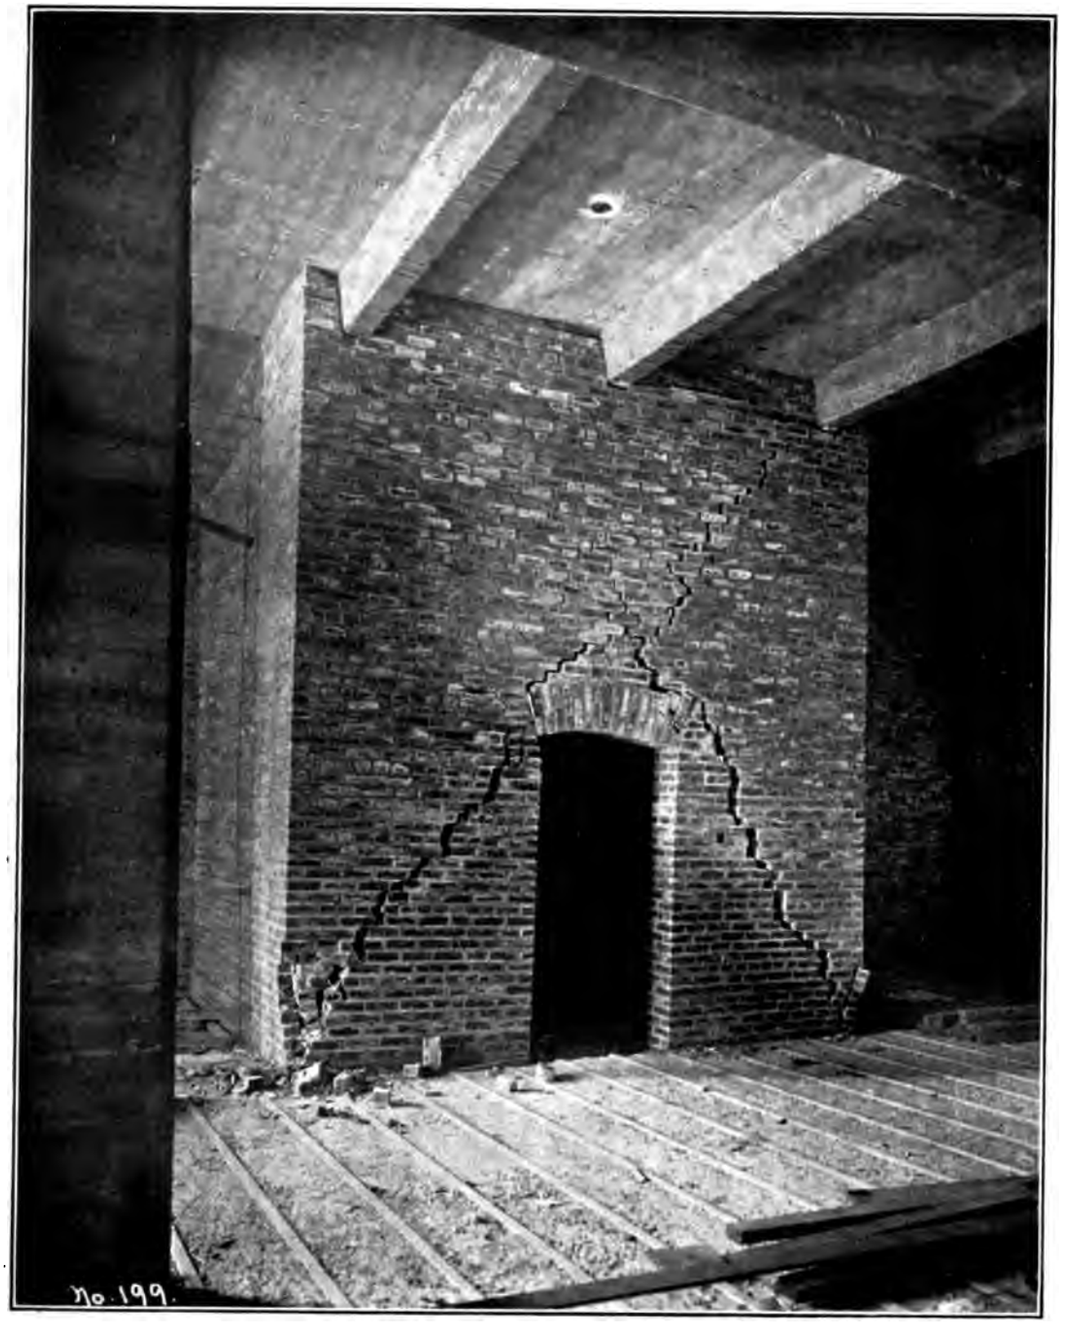
CALIFORNIA CASKET CO.'S BUILDING. Second Story. Showing the earthquake damage to a brick vault built between the Roebling concrete floors. A similar vault on the first floor was completely destroyed. In the upper stories, the vaults were similarly but less damaged by the earthquake. The Roebling crimped wire is in position on the soffits of the beams and girders ready to receive the cement plaster. The column at the left-hand side is protected with concrete by the Roebling method.

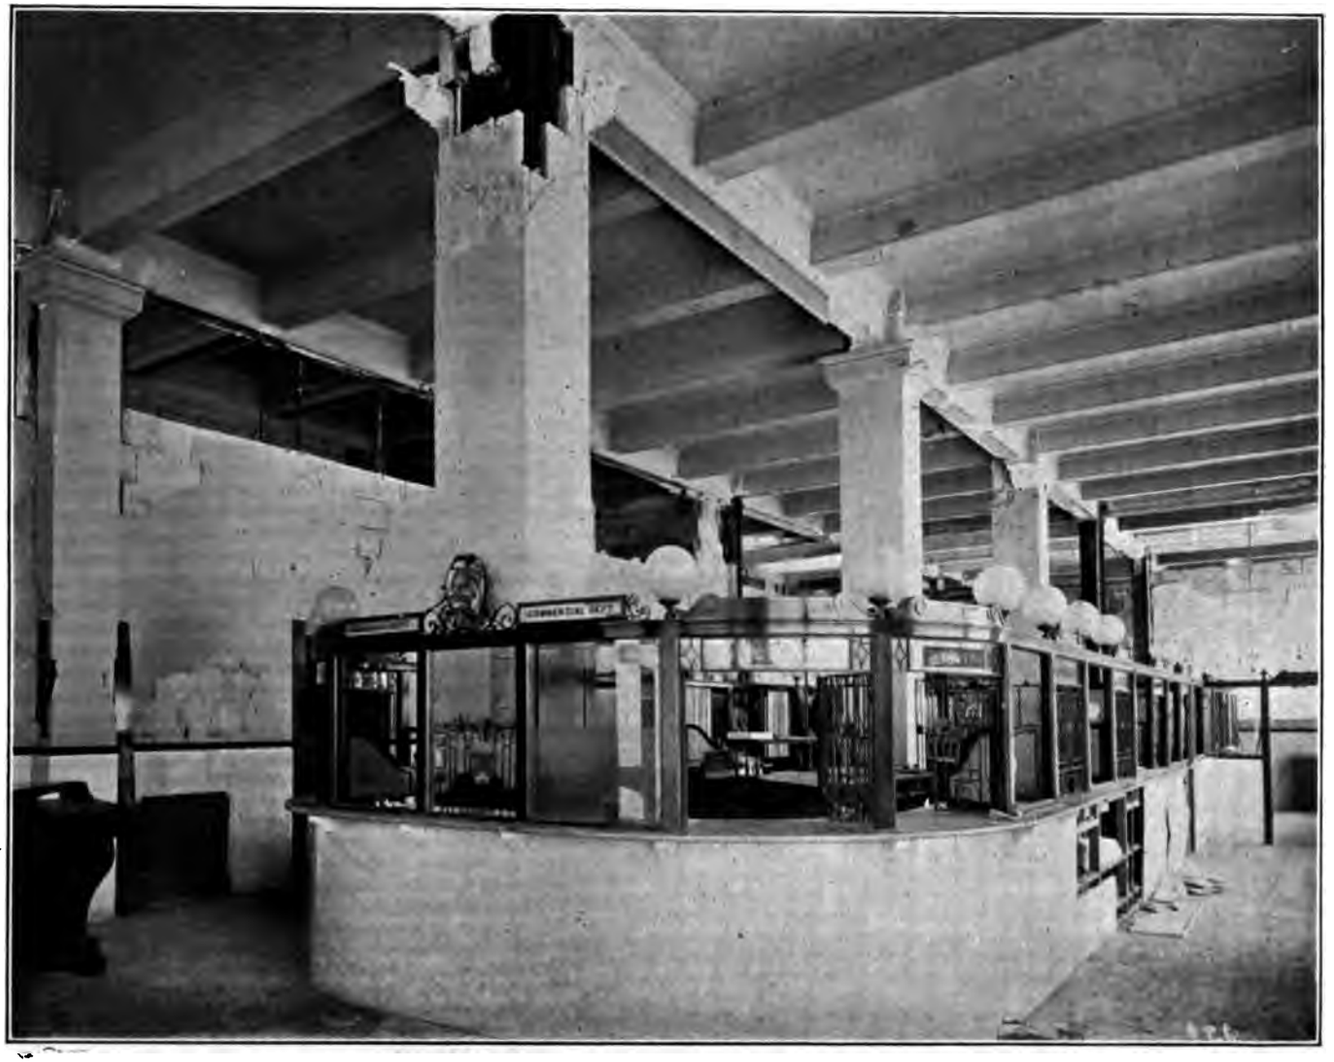
GRANT BUILDING. First Story. Showing the banking room of the Market Street Bank. There was no fire in this room. The damage shown in the photograph was caused by the dynamiting of the Odd Fellows' Building on the opposite side of the street. Roebling concrete floors were used throughout. The column protection and partitions were of hollow tile. The fire consumed everything combustible in the rest of the building.

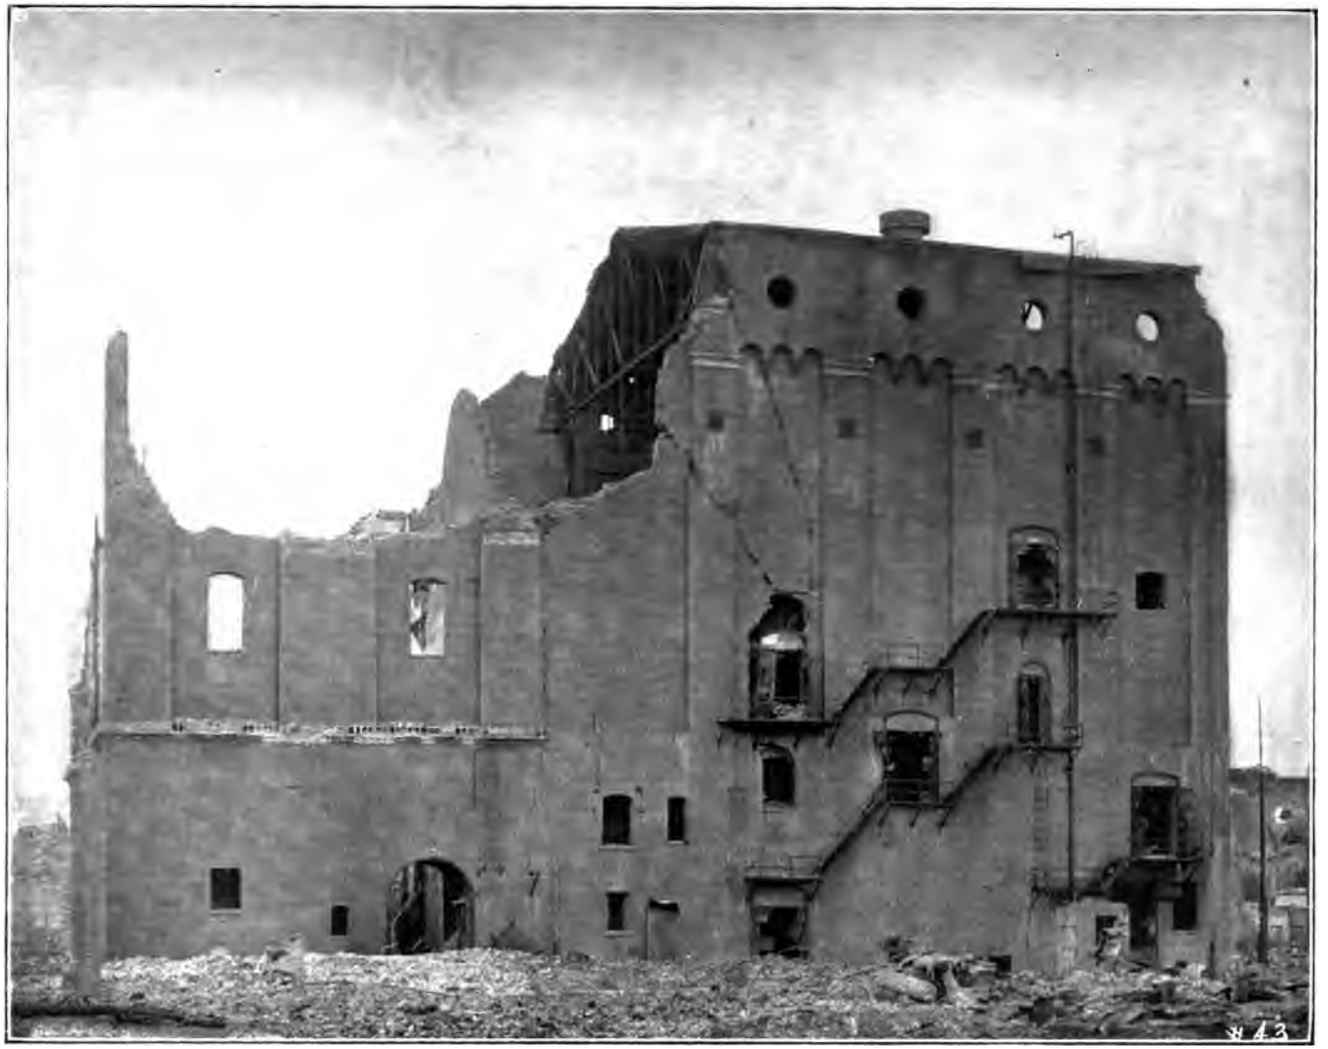
MAJESTIC THEATRE. Northeast Corner Ninth and Market Streets. This building had an entrance by an arcade from Market Street through a Class B building, which was destroyed by the fire. All the walls are bearing walls and of common brick with terra-cotta ornamentation. The left-hand side is the stage portion of the building, and was totally wrecked by the earthquake. The gable wall at the opposite end of the building was also shaken out, large portions of the brickwork falling upon the gallery tier and being supported by it. Roebling concrete floors and ornamental furring and lathing were used throughout. Note the floating section of brick wall cracked loose and supporting a large truss of 75 feet span, about 80 feet above the ground. The loose section of the wall has moved horizontally so that the side of the pilaster is 4 inches out of line.

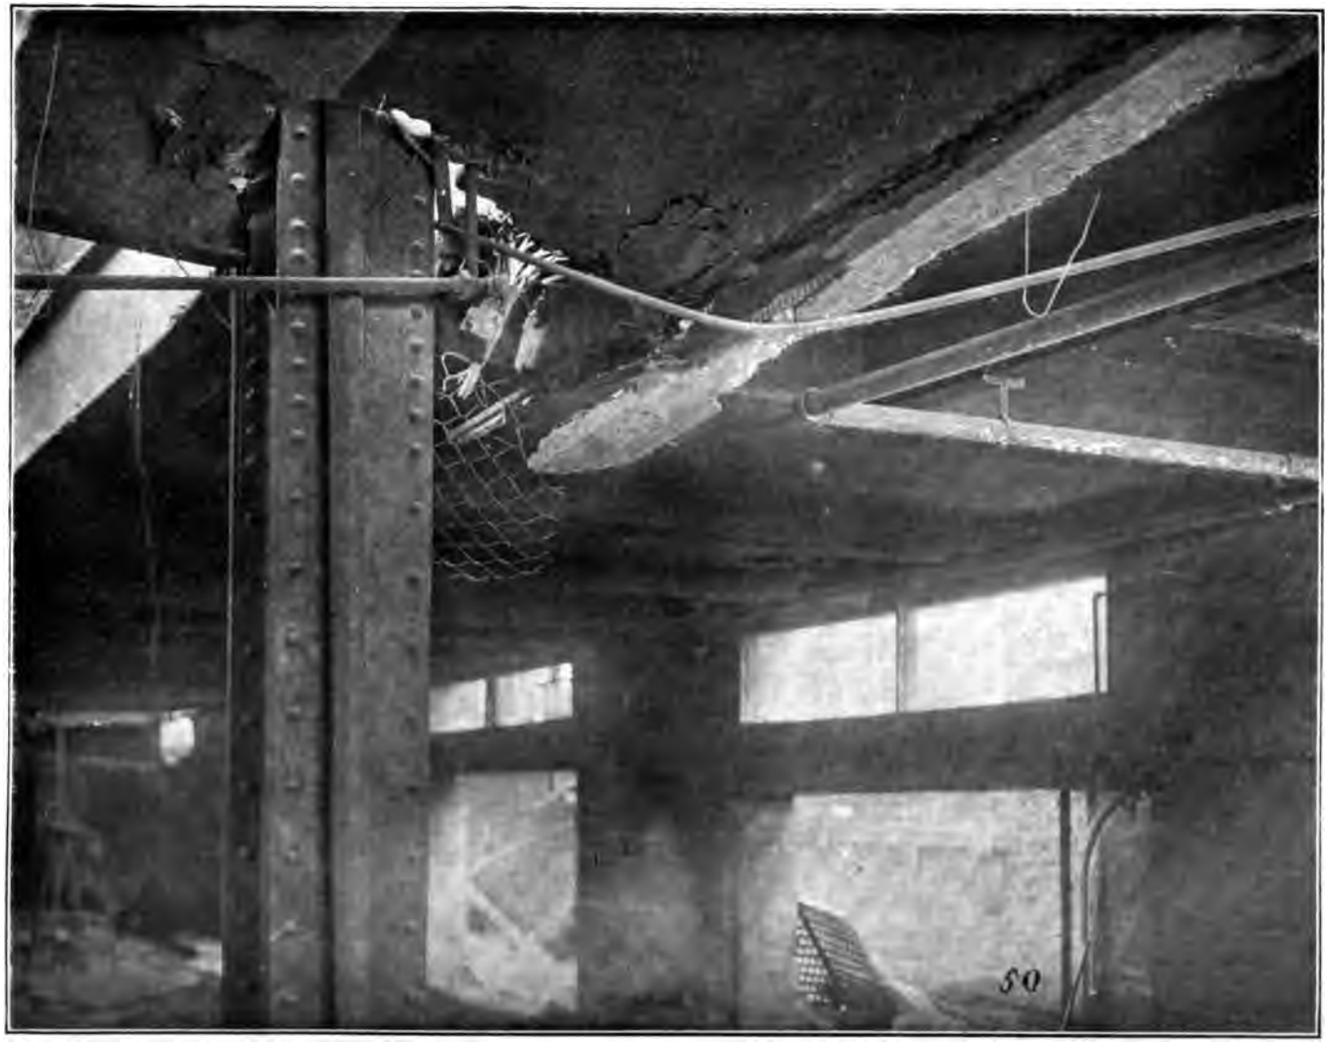
MONADNOCK BUILDING. Basement Story. Showing the damage to reinforced concrete beams adjacent to the bay that was disrupted by dynamite.

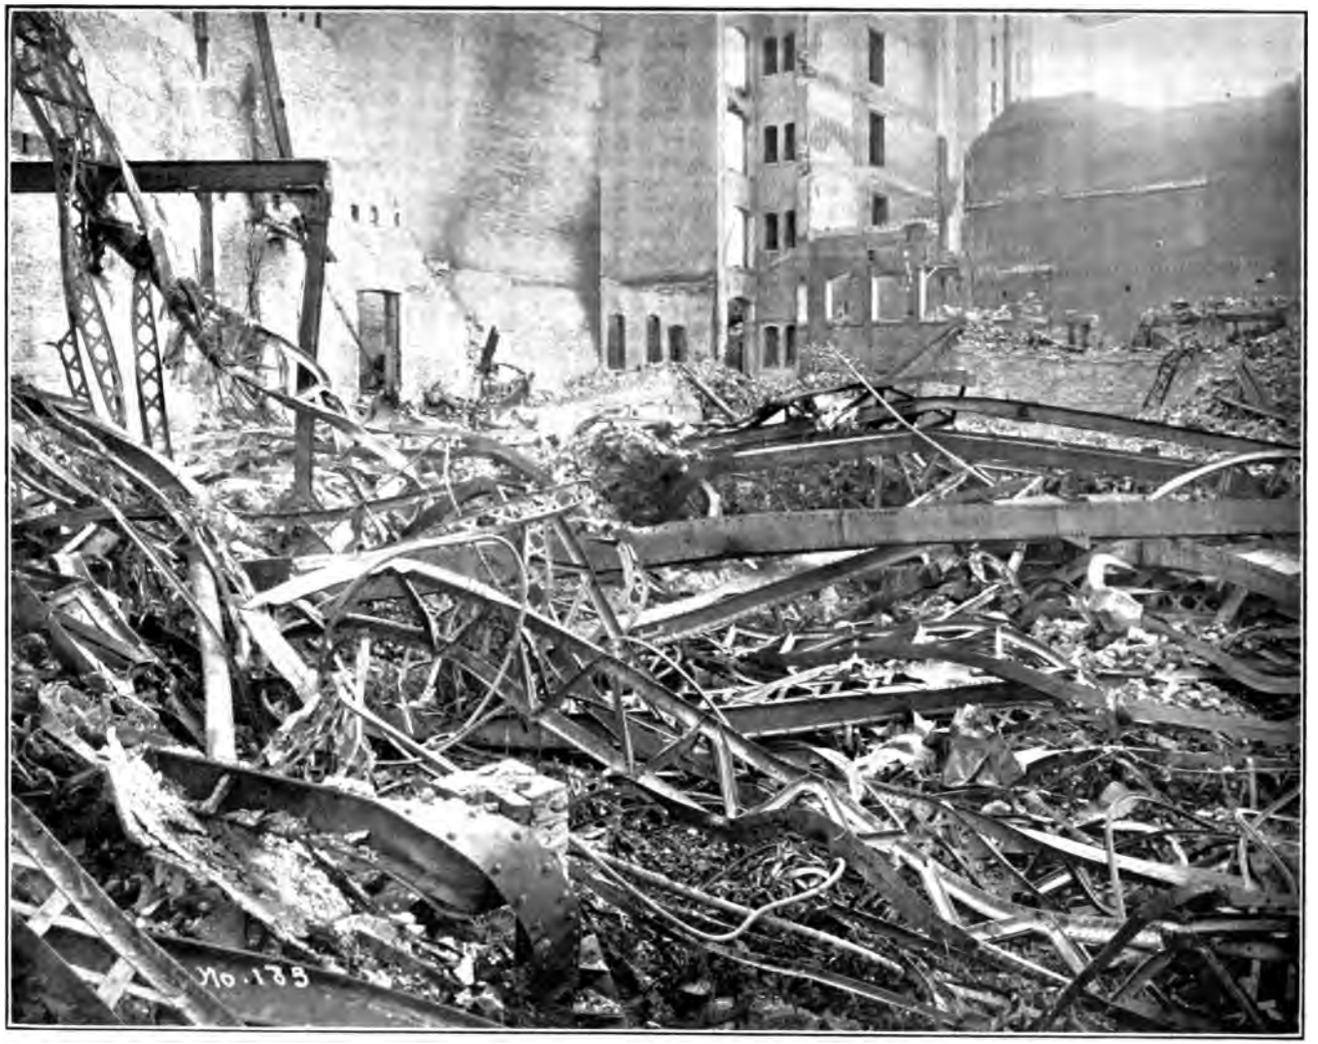
TIVOLI OPERA HOUSE. Showing the ruins of the auditorium and stage portions, which were of non-fire-proof construction. The floors and finish were of wood, the floor loads being carried on steel framing and bearing walls. In these ruins were evidences of the hottest fire noted in the burned district. Expanded metal lath was incinerated. Latticed angle column sections and light trusses were blistered and burned so that they parted, $\frac{1}{4}''$ metal being reduced at the fractures to the thickness of ordinary pasteboard. The three-story entrance portion of the building is of fire-proof construction and remains standing.

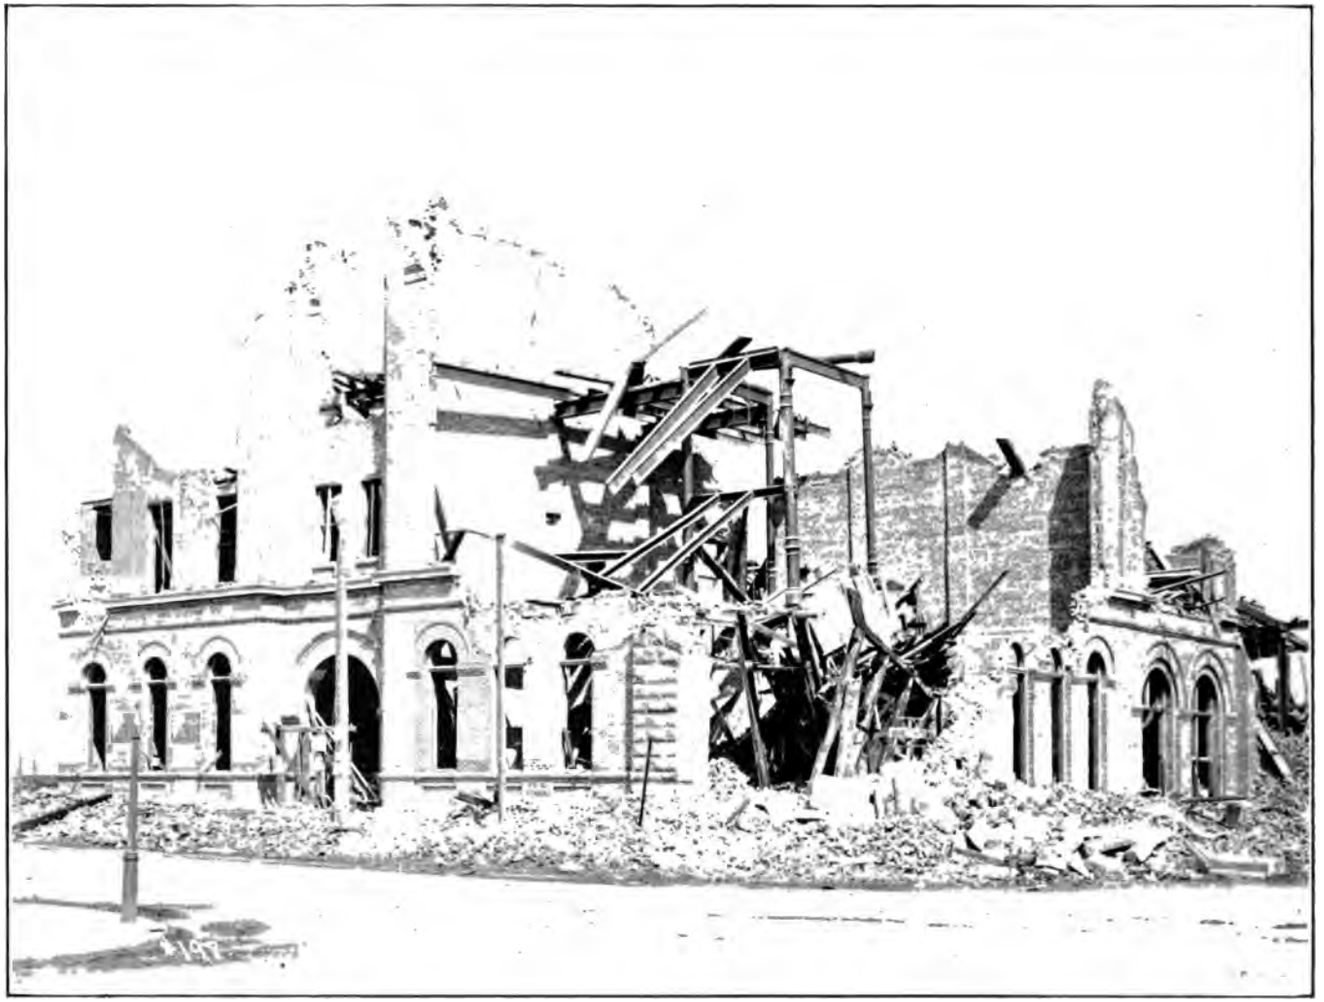
JACKSON BREWERY. Northwest Corner of Eleventh and Folsom Streets. This building was in the course of construction and was totally wrecked by the earthquake. Lime mortar of poor quality was used. All the walls were bearing walls and were not tied together. Fire did not enter the corner of the building shown in the foreground, but consumed everything combustible in the rear. Note the five beams at the third story level projecting toward the rear which carry a load of brickwork on planking, with no other support than the angle connections to the girder at one end.
